## INTERNATIONAL ASSOCIATION OF DRILLING CONTRACTORS

17 January 2014

**Comments received from industry:**

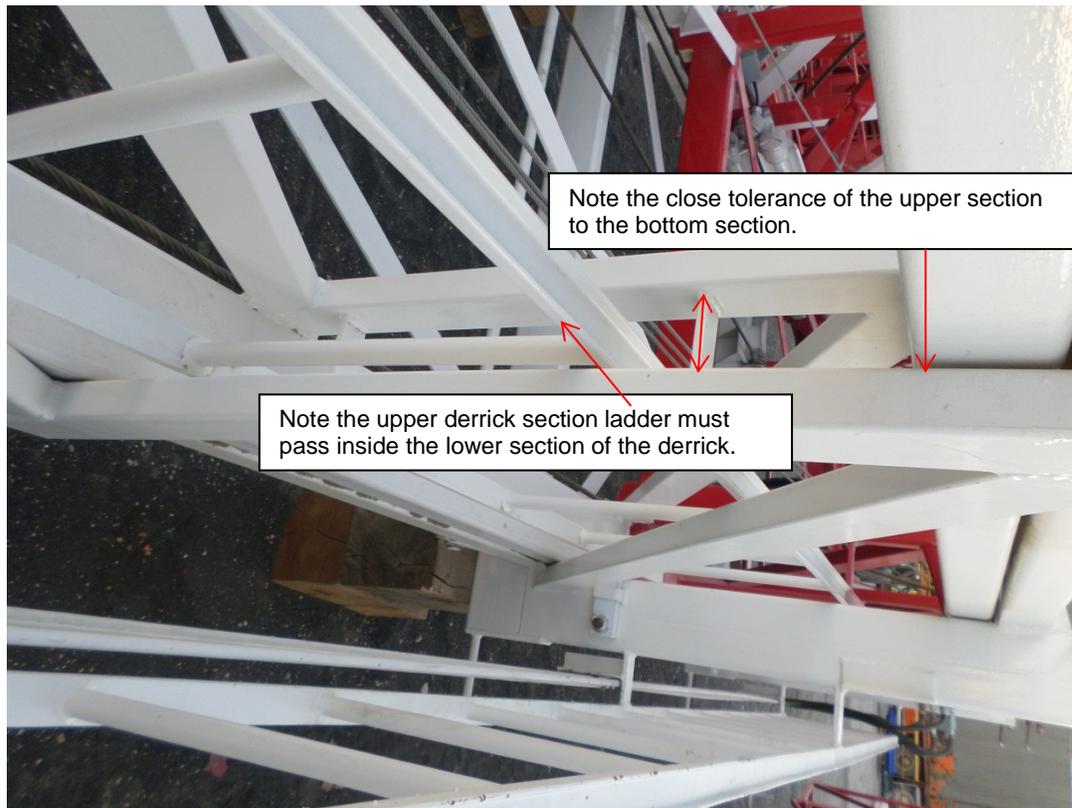
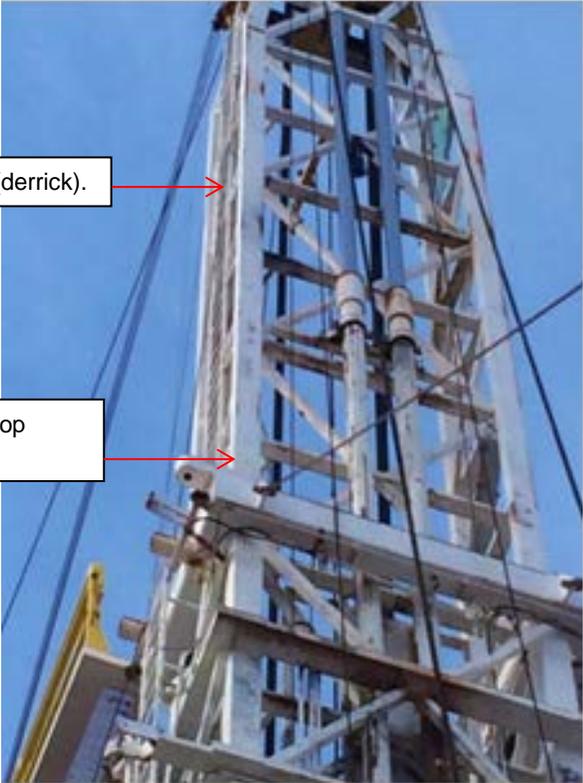
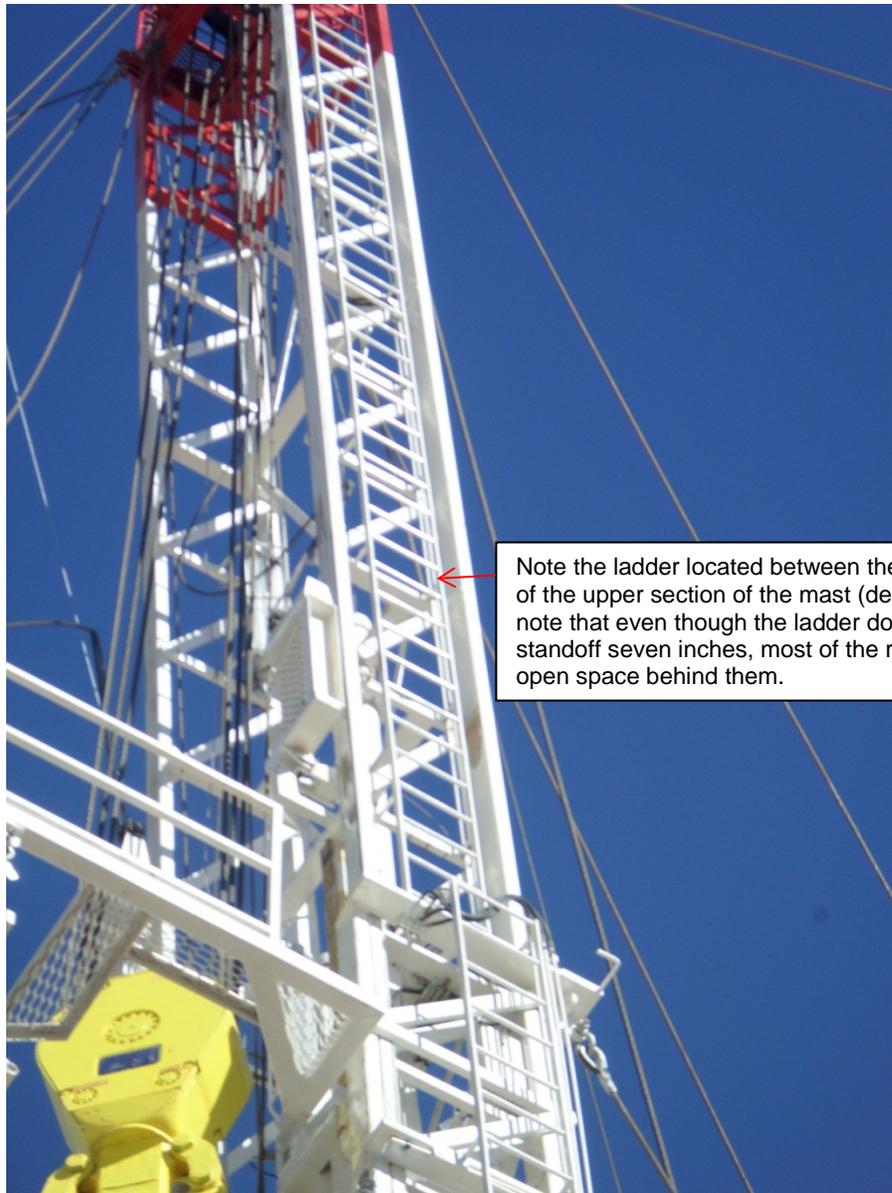
**See the following picture showing the close tolerance required between the upper and lower section of the mast (derrick).**

Note the ladder mounted to the mast (derrick).

Note the close tolerance between the top section and the bottom section.

***In order to provide the required load line transfer from the upper section to the lower section of the mast (derrick) there are close tolerances that must be met. It is not feasible to widen the lower section of the mast (derrick) to make room for the ladder just as it is not feasible to make the upper section narrower. Changes in either will result in a mismatch of the sections and create a hazard of the mast (derrick) collapsing.***

**Another option was investigated was to narrow the inner/upper telescoping section of the mast to allow clearance for the ladder. This creates multiple issues. 1) The load path is inset at the load transfer point between the upper and lower mast sections changing the force from a shearing force for the load transfer with flush sections to a leveraged force with offset sections. 2) The upper cross section is narrowed increasing the potential for the traveling assembly to strike the mast due to normal wind deflection and block deviation with differential sheave tension and drill line torque.”**

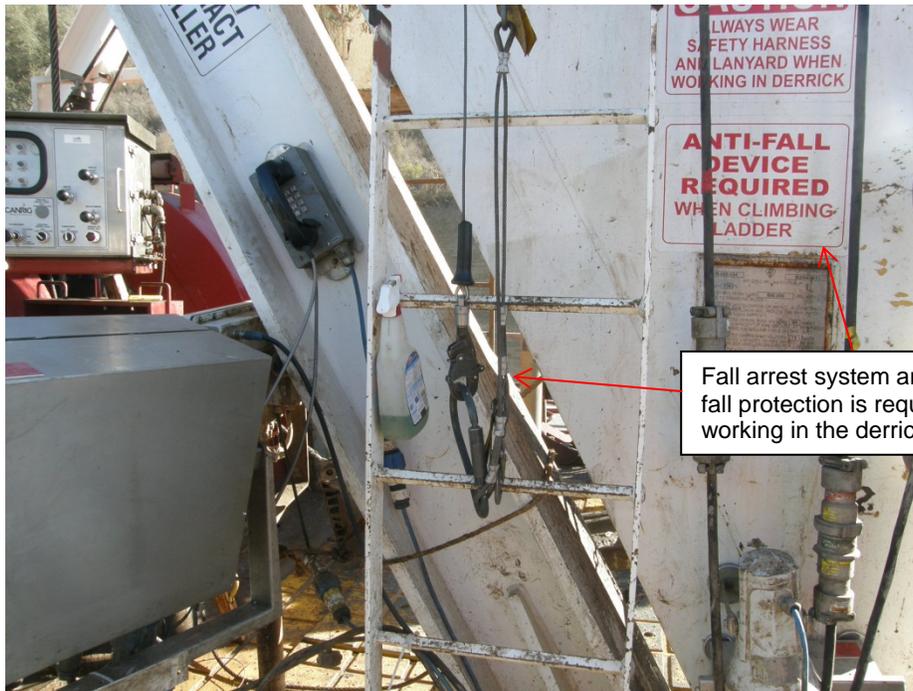
Note the fall arrest device that is attached to the crown structure of the mast (derrick).

**All member companies have indicated that they are using fall protection systems on derrick ladders. They believe that the use of fall protection is more critical to the safety of their workers than having a ladder with seven inch standoff that could be damaged when telescoping out or in of the derrick sections. None of the companies responding reported any incidents that were the result of a derrick ladder that was not fully in compliance with the regulations.**

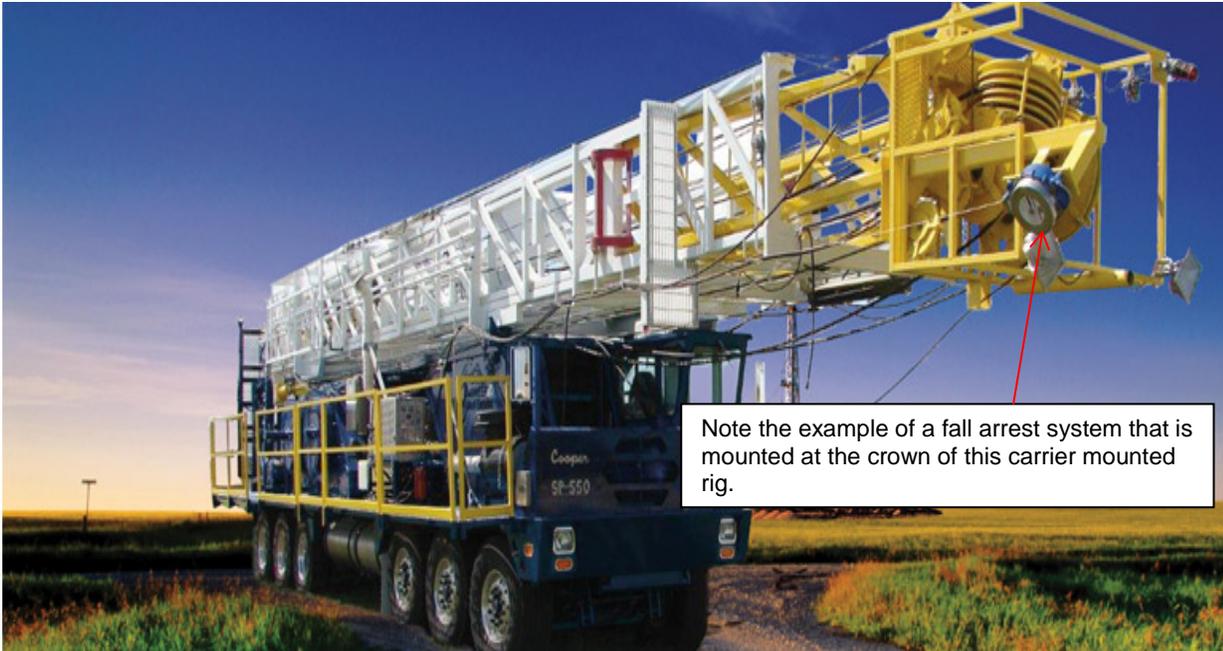
Fall arrest system and notice to personnel that fall protection is required when climbing or working in the derrick.
