Safety Alert

ALERT 06 – 13

DROPPED OBJECT FROM DERRICK

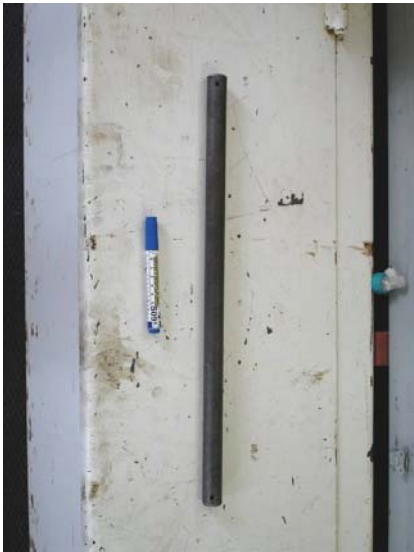
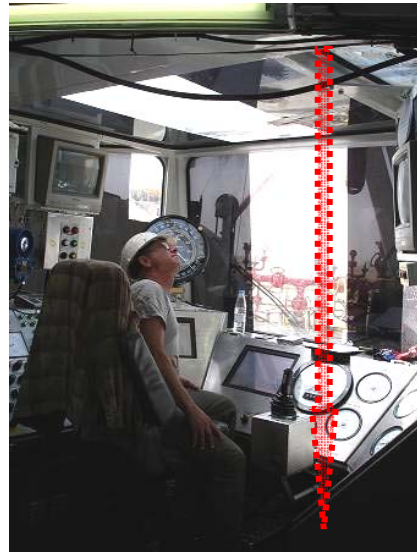
The incident occurred when a stand of drill pipe missed the elevators, fell across the derrick towards the driller's side and struck the derrick structure. This impact dislodged a 2 foot x 3/4 inch steel bar weighing approximately 3 pounds from the stabbing board ladder platform causing it to fall approximately 30 feet to the dog house below. The steel bar struck and passed through the upper dog house window, narrowly missing the driller. The window was constructed of shatter proof material but was not able to withstand the impact of the bar.

- No formal derrick/dropped object inspection process was in place.
- No derrick log book was being used to monitor flow of tools up and down the derrick.
- The steel bar had no safety line attached, it had not been safely secured during or after use.
- No toe boards were in place around the ladder platform.
- The glass in the dog house window was not substantial enough to withstand the impact sustained.

- The area was immediately made safe and a safety stand down called and a dropped object sweep of the derrick was carried out. 10 potential dropped objects were found and removed.
- The company told the rig crews that a weekly formal derrick/dropped object inspection process would be implemented, monitored and enforced.
- A derrick log book to monitor flow of tools up and down the derrick would be implemented, monitored and enforced.
- Any tools or equipment being used while working at height is required to be secured with a safety line.
- Toe boards are required to be installed around the out skirts of any raised work areas or platforms.
- Reinforced glass shall be installed on dog house roof windows; a bolt on frame will be fabricated to allow the window to be sloped.
