Safety Alert

ALERT 06 – 18

NEAR MISS - DRILL STRING PARTS WHEN BOP PIPE RAMS ARE LEFT CLOSED

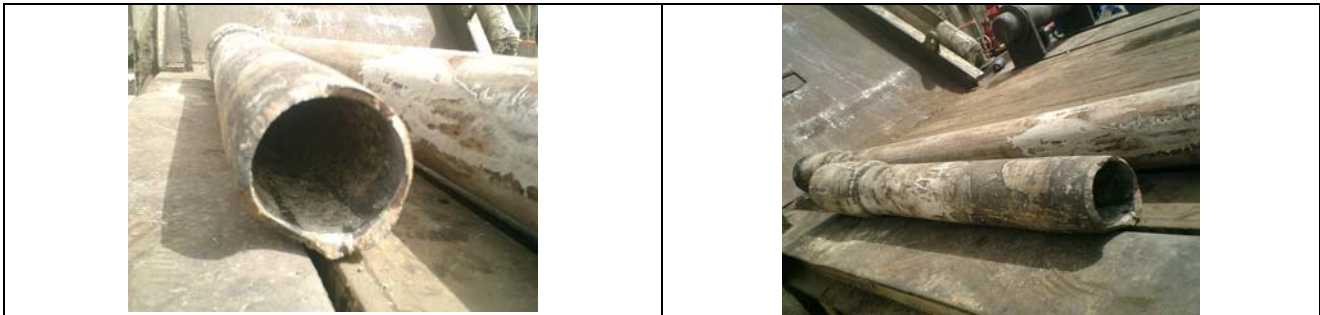
After conducting a routine Hydrogen Sulphide (H₂S) drill and returning to drilling mode. The Driller engaged the drum clutch and picked up the drill string while the BOP pipe rams were still in closed position. As a result the drill string parted at the slip area reaching its maximum tensile yield of the first joint that was being hoisted. The elevators and the links jumped violently when the pipe parted and approximately 4 foot of broken drill pipe dislodged from the elevators which were approximately 15-20 feet above the rotary table. Before landing on the drill floor the dislodged pipe brushed the right shoulder of a floor hand standing in the immediate area. Two other floor hands were also working the rig floor at the time.
