Safety Alert

ALERT 05 – 03

IMPROPER TOOL SELECTION RESULTS IN INJURY

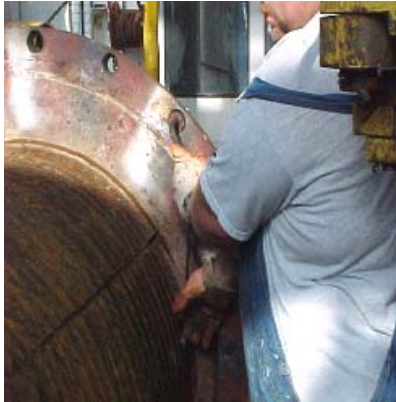
Two crewmembers were working together to remove the Allen head bolts that secure the drawworks brake flanges to the drum. The drum had been removed from the skid and secured on the rotary table. The tools selected for the job were a ¾" drive impact wrench and socket, and a standard 9/16" Allen key. The tools were fitted up and the impact wrench was engaged. The tapered fit friction of the Allen head end of the bolt allowed the nut to break initially without applying torque against the Allen key. The impact wrench operator continued and as the nut loosened, friction lock was lost and the torque was transferred to the Allen key because lock nut was still bound to the bolt. The Allen key shaft length was a standard size and not long enough to react against the drum. The torque now being applied through the bolt to the Allen key was more than the other employee could hold. The Allen key slipped from his hand spun 3 or 4 times and was thrown free. The Allen key struck the injured employee in the forehead and above the upper lip requiring stitches in both places.

The investigation revealed that there had been little consideration to tool selection other than that they did fit, and were in good shape. The potential hazard associated with using an impact wrench which turns at high speed with a (short lever arm) standard Allen key were not considered. While the tools did fit and were in good condition, it was obvious that they were inappropriate for the task in the way they were used. Impact wrenches free spin at several thousand rpm, and generate significant torque output at several hundred rpm. The back-up wrenches used with impact tools must be firmly secured and personnel clear from harms way.

Flange with Allen wrench in bolt

Jobs requiring impact tools should be listed on the rig.

Each job should be studied to see if a "back up application" exists

In cases requiring back up ensure that the back up can be secured in a hands free mode.

Safety meetings should be held with all crews to discuss the danger of high-speed air tools.

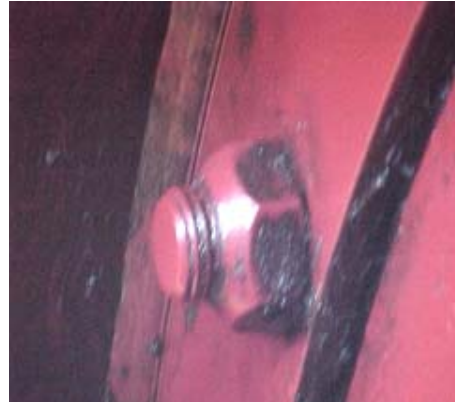
Nut that Impact wrench was attached.
