# Safety Alert

ALERT 11 – 09

## IMPROPERLY MOUNTED RIG FLOOR WINCH RESULTS IN HI-POTENTIAL NEAR HIT

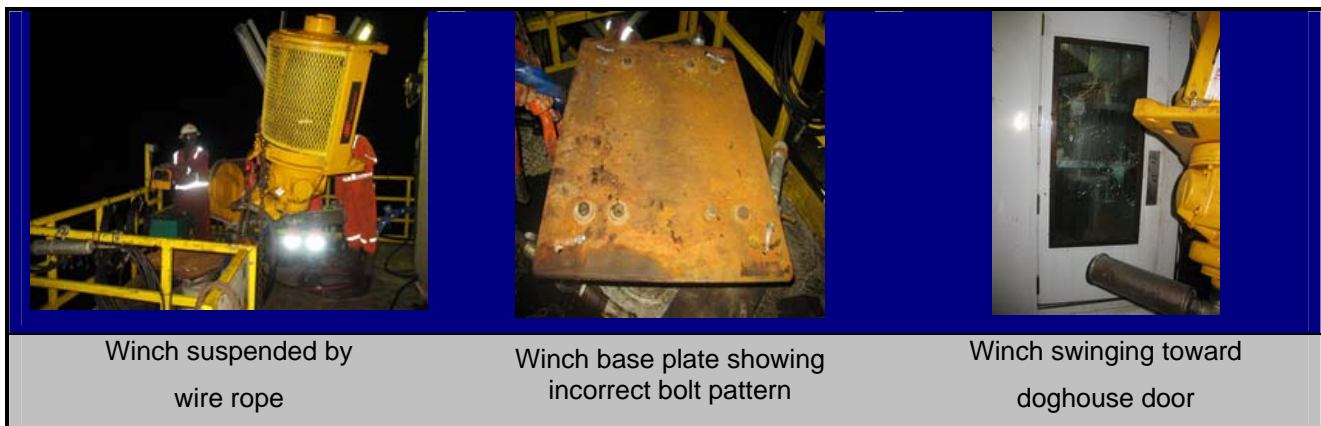
During operations on the drill floor the crew was in the process of picking up riser through the V-door. They were using the 4500 kg winch for pulling back the riser to permit racking of the riser into the V-door. As the riser was being picked up, the winch bolts holding the winch to the pedestal failed and the winch broke free from its pedestal. When the winch broke free from its mount and was suspended by its wire rope, it swung sideways and smashed the glass on the doghouse door. The riser then slid back down the V-door and came to rest on the V-door stopper.

- The original winch base did not have the same design or bolt pattern as the base holding plate and required modification before use (holes were misaligned).
- Failure to recognize situation as requiring Management of Change (MOC) controls.
- Undersized bolts used to secure the winch to its base failed under load.
- There was no follow-up inspection record of the modification or load testing performed.
- Wrong team members were involved in the installation

- Check all lifting equipment before use for damage or potential mechanical failure.
- Follow Management Of Change (MOC) process to plan the scope of work and who needs to be involved at each phase.
- Renewal and modifications to equipment are to be checked by OIM, Maintenance Supervisor and QHSET Officer at a minimum (Tourpusher to be included for Drilling equipment and Barge Engineer for Marine equipment).
- Any load bearing equipment should be load tested to SWL before use.
