Safety Alert

From the International Association of Drilling Contractors

ALERT 08 – 31

THUMB INJURY RESULTS IN LTI

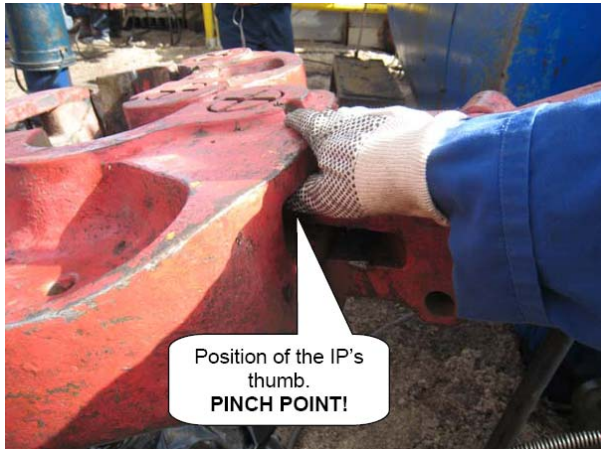
Due to a malfunction the rig crew was instructed to lay down the Measurement While Drilling (MWD) tool. The make-up tong was placed around the mud motor and latched. The break-out tong was placed around the MWD tool and an attempt was made to latch the tong when the injured person (IP) placed in the thumb of his right hand between the lever and the long jaw of the tong. His thumb was caught between the jaw and tong body, removing the flesh from the end of his thumb. The removed flesh could not be reattached and the bone had to be amputated and the stump of the thumb sewn closed.

This situation was a repeat of an incident that resulted in a lesser injury three months previously. The prior incident involved the same crew as this incident. Following the prior incident, several safety meetings, refresher training and pre-job meetings addressed the topic of hand and finger safety. Prior to this incident, hand safety was discussed at the pre-tour meeting, a pre-job meeting and reminders and guidance was provided by the Rig Manager who was on the brake at the time.

- The IP knew he had his hand in the wrong position.
- The IP had 1.5 years of experience working on the rig floor.
- The rig is fitted with an Iron Roughneck resulting in the crews being less familiar with manual tongs (only used when running Bottom Hole Assembly)

The following learning/corrective actions have been identified and implemented:

- **Awareness:** All personnel will attend further refresher/awareness training on hand and finger hazards.
- **Communication:** Effective communication is essential for safe operations. If there are any doubts or misunderstandings, ask for clarification. ASK first, ACT later.

- **Procedure/Work Instruction:** Where there is a history of deviation from work instructions or procedures or instructions are not followed, an assessment into the person's suitability for the position will be undertaken.
