SAFETY **ALERT**

Blind Shear Door Blown Off BOP Body

Alert 7-21

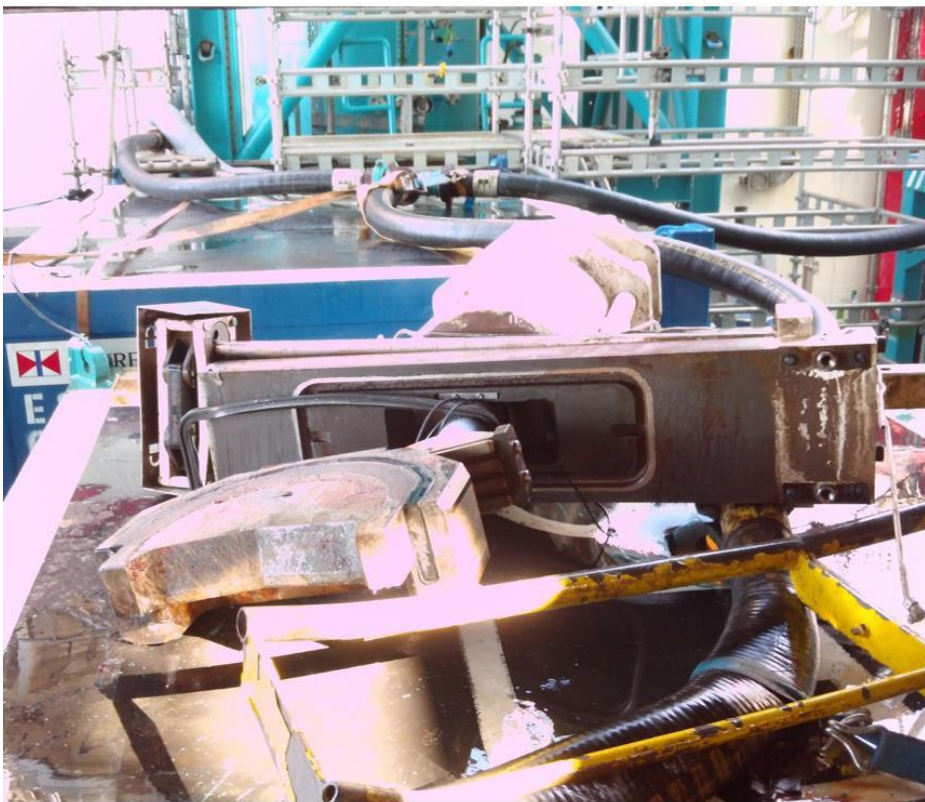
During a high-pressure test of the Blow Out Preventer (BOP), one of the Blind Shear Ram (BSR) doors blew off the BOP body. The door was found resting on top of an adjacent equipment container, approximately 5 meters (16 feet) to the port side of the BOP.

Picture 1: BOP Door and Ram on Top of Container

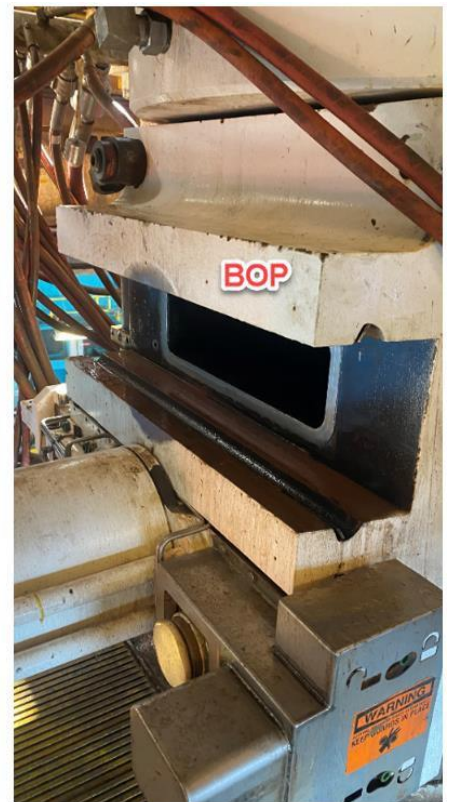
The pressure test took place using the cement unit after nipple up of the BOP. The test started with a low-pressure test to 20 bars (290 psi) and held for 5 minutes. While increasing the pressure to a planned 570 bars (8,267 psi), the BSR door blew off when the pressure reached 109 bars (1,580 psi).

Picture 2: BOP Body Where Door Separated

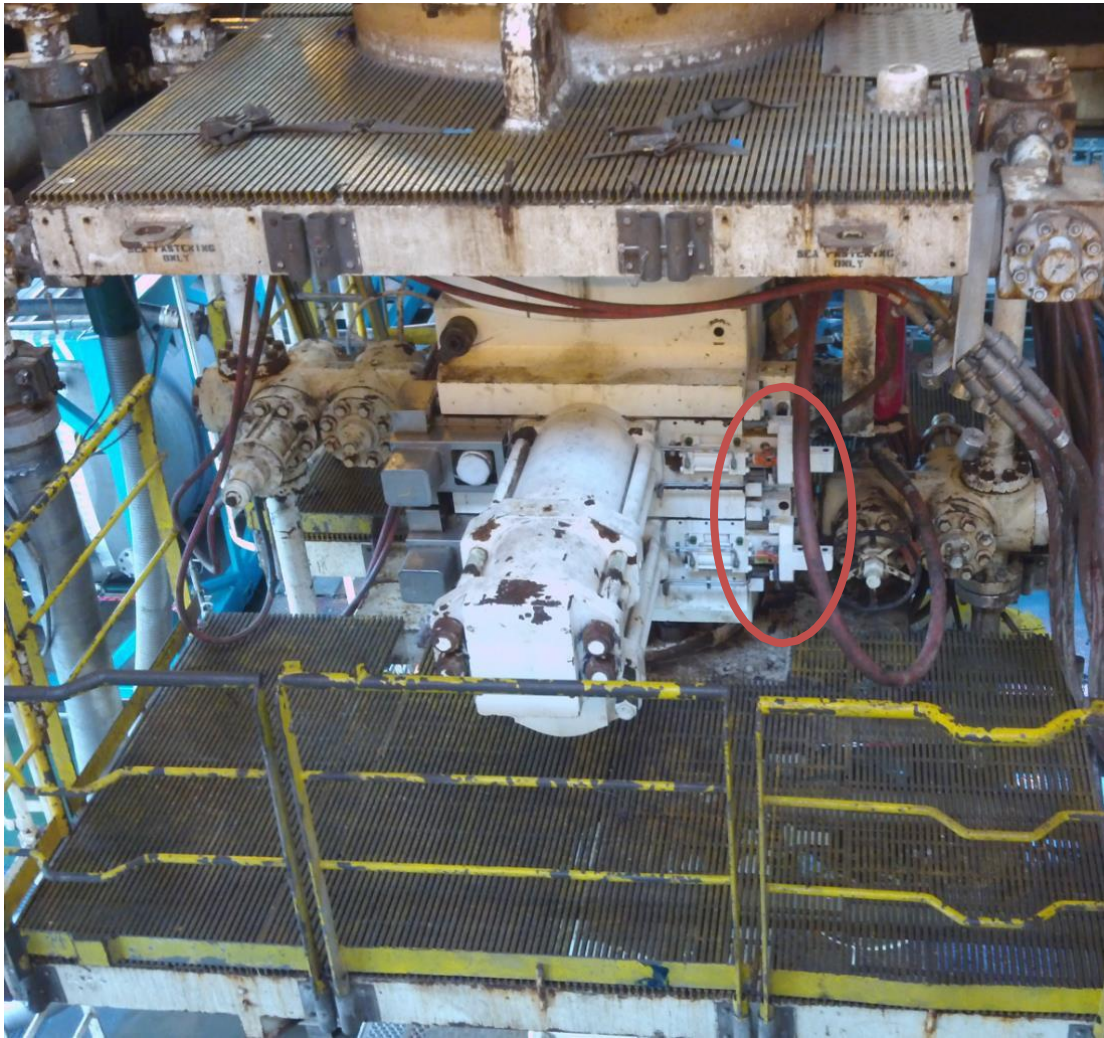
Before the pressure test, the BOP doors were opened for inspection and replacement of the middle pipe RAMS was carried out. During the reassembly of the BOP doors, the anti-rotation bars were not engaged.

Picture 3: BOP with Anti-Rotation Bar Disengaged

- Incorrect use of locking system – Maintenance personnel did not engage the anti-rotation bar after reassembling BOP as described in the work instruction.
- No independent verification of correct locking – Drill crew did not conduct second verification of BOP before the pressure test as required by the work instruction.

- Ensure BOP maintenance personnel are knowledgeable of BOP door locking mechanism.
- Ensure BOP maintenance and testing procedures mandate second verifier for BOP door secondary lock activation.
- Work with manufacturer and human factor specialist to enhance the secondary lock design and mitigate the risk of human error.

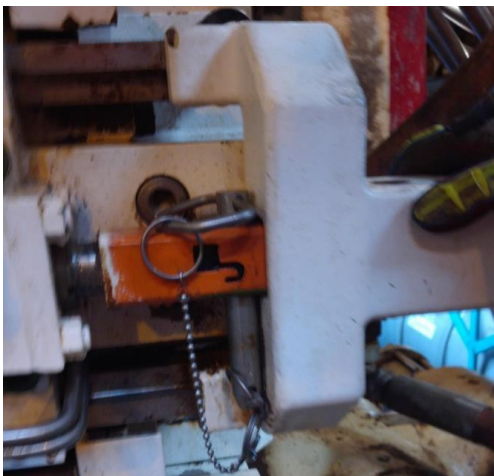
Picture 4: Anti-Rotation Bar in Unlocked Position

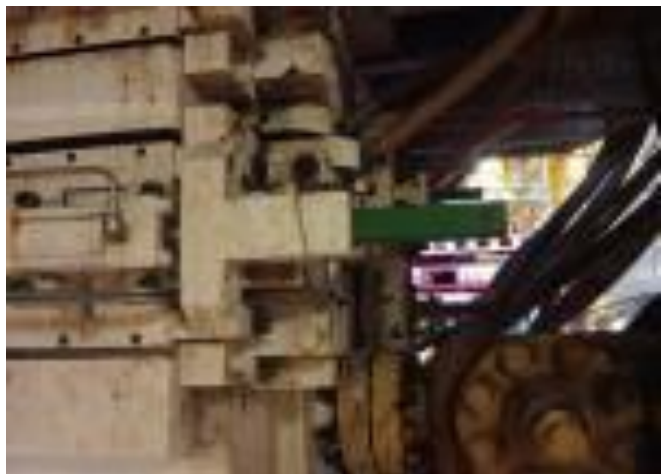
Picture 5: Anti-Rotation Bar in Locked Position
